# Multi-Purpose, High Temperature Repair and Rebuilding System

Belzona 1511 (Super HT-Metal) is a high temperature, paste-grade system for rebuilding equipment damaged by erosion-corrosion. This material can also be used as a high-strength structural adhesive or for the creation of irregular load bearing shims.

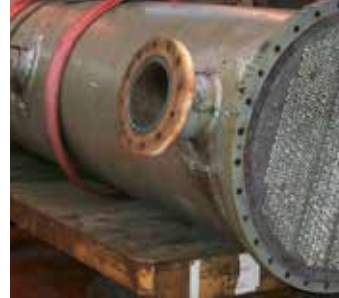
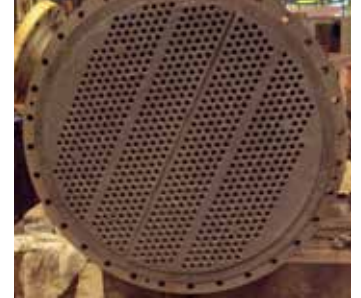
Heat exchanger tube face damaged by severe galvanic and pitting corrosion. Rebuilt with Belzona 1511 prior to the application of a Belzona high temperature coating.

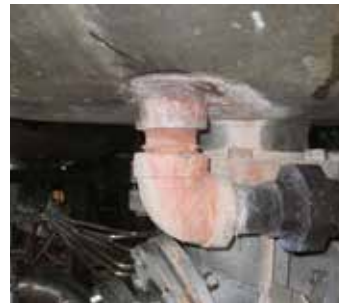
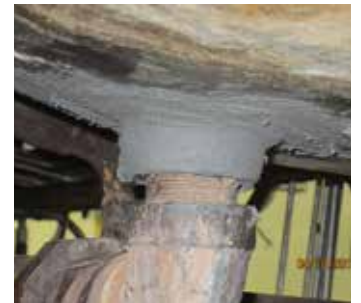
Process kettle developed holes in the weld seam as a result of corrosion. Belzona 1511 used to repair holes for the long term.

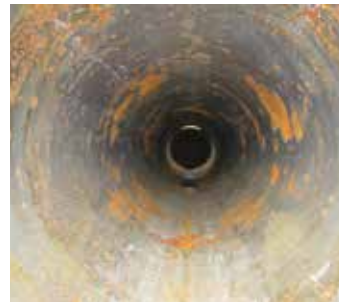
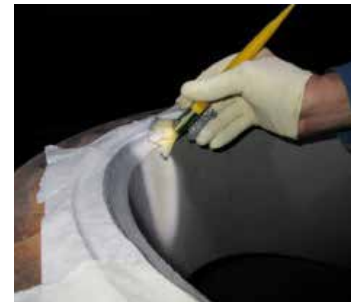
High temperature vessel suffering from severe corrosion. Pitted surface rebuilt using with Belzona 1511.
